A COMPREHENSIVE LITERATURE SURVEY ON THE CORROSION RESISTANT TECHNIQUES USED FOR THE STEEL BEAMS

ABSTRACT

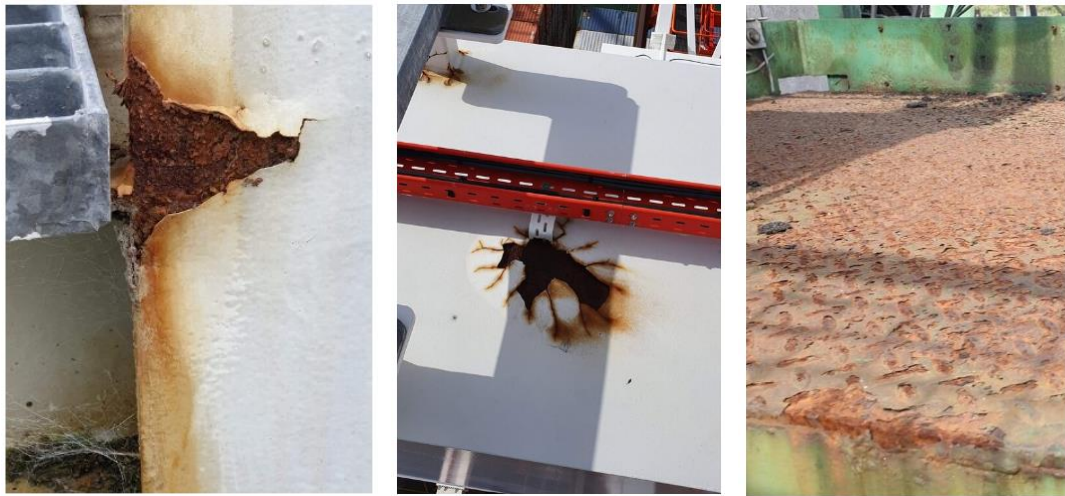
Figure Error! No text of specified style in document. (a) Galvanic Corrosion (b) Localised Corrosion (c) General Corrosion

The joining of two metals with very different properties causes this effect. A stainless bolt through a steel beam is a good illustration of this. Of course, the two metals are dissimilar, with the more noble metal eventually succumbing to corrosion while the less noble metal holds up rather well for a while. Usually the most dangerous kind of corrosion, it may cause fast structural decay.

This may happen anywhere on a steel surface, as well as the source is often unknown. Scratches in the paint (maybe from another machine) or structural alterations without proper recoating processes are two common sources of localised corrosion.

This represents a surface-wide loss of mass at a same rate. Although it may have a deteriorated appearance, the steel's structural integrity is usually unaffected. More rust means the steel is in better condition, in most cases.

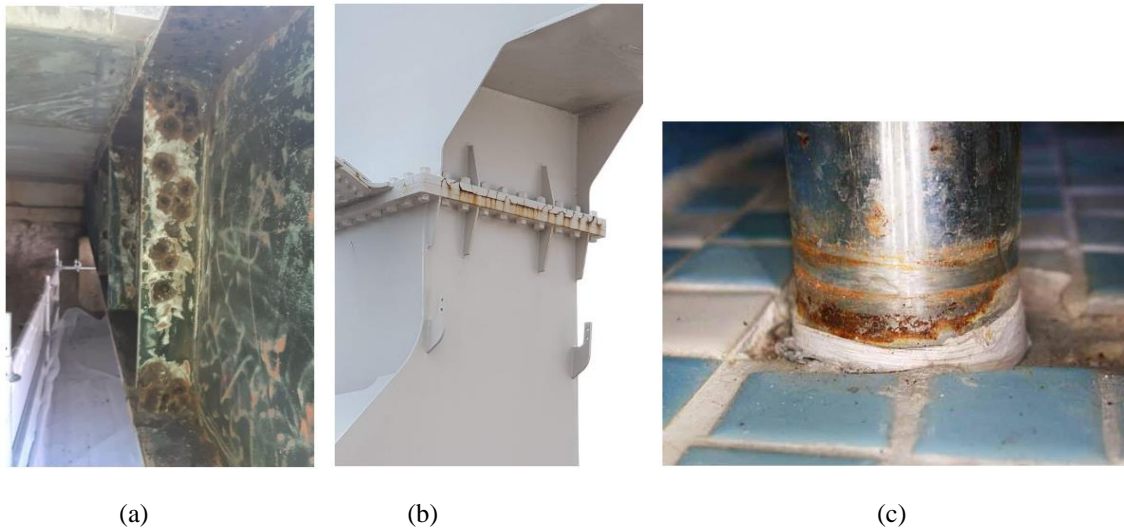
Figure 2 (a) Pitting Corrosion (b) Crevice Corrosion (c) HASCC- The Invisible Corrosion

Corrosion has been going on for some time as seen by the little holes it has created in the steel. It often occurs on the unprotected steel buildings and uncovered pipes. While the pitting may be difficult to see at first glance, it may completely eat away at a steel flange with just a tiny amount of the metal loss, compromising the structure.

This takes place on a metal surface which is partially protected from the elements by another material that fills the space between them.

When steel beams are linked, it is important to check for signs of crevice corrosion, which may be reduced using wax sealers or something similar. This may be challenging since, as the figure indicates, galvanic corrosion typically occurs along with this problem, and the structure usually cannot be disassembled to clean them adequately. The lifespan of any building may be extended via consistent upkeep.

Failure may also occur as a subsequent outcome of a galvanic response, which is why it is so deadly. Standard fasteners may be weakened and eventually fail by hydrogen, a byproduct of galvanic corrosion. It causes rust that shows no outward signs until it's too late. In HASCC, hydrogen embrittlement is the first step. When hydrogen is present, galvanic activity occurs, leading to embrittlement. Galvanic corrosion, however, does not weaken steel fasteners.

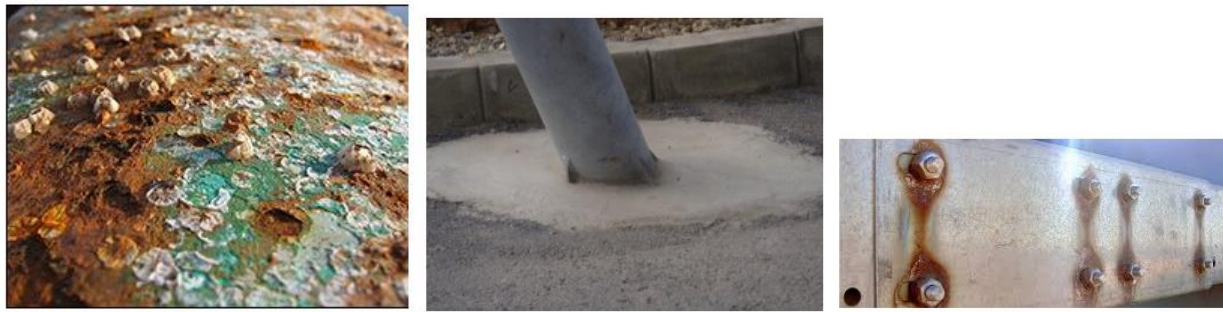
Figure 3 (a) Biochemical corrosion (b) Aeration cell corrosion (c) Bimetallic corrosion

Due to their propensity to interact with oxygen to produce oxides, metals are susceptible to chemical corrosion, a process that sees them dissolved in acids as well as caustic solutions of varying intensities.

As a result of being kept at an unnaturally warm temperature, oxygen levels drop. Condensation forms in bed linens, attracting pollutants. Corrosion may occur even in non-polluted, high-pH locations if oxygen supply is cut off there. Corrosion rates are higher in environments with a lower pH value, as might occur when other contaminants are present.

Corrosion happens when two metals that aren't chemically compatible (like iron & aluminium) are brought together in an electrolyte. Since the electric potential of different metals can be mapped out in a chart known as the "galvanic series," this makes sense.

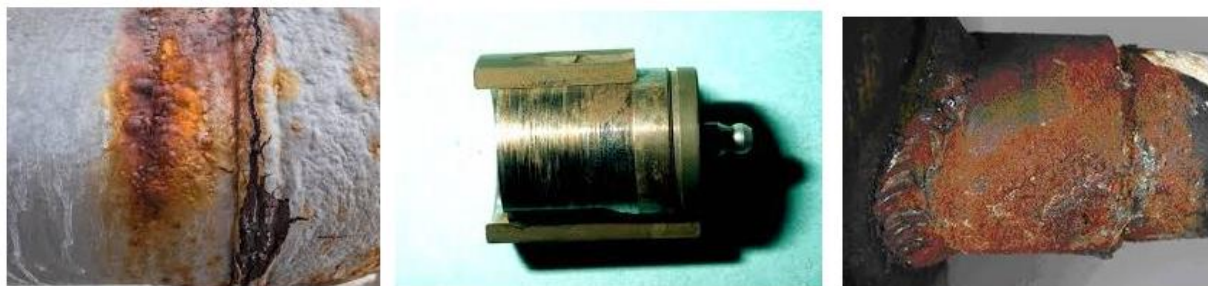
Figure 4 (a) Stress Corrosion (b) Fretting Corrosion (c) Bacterial Corrosion

This takes place when a certain corrosive environment is combined with static tensile tension. Some areas of the body (particularly the stress hotspots) become more anodic due to stress than others. While corrosion like this is uncommon with ferrous metals, it may happen with certain types of stainless steel.

The oxide coating may be mechanically removed from high areas between contacting surfaces if two oxide coated films or corroded surfaces are rubbed together. When contrasted to the surrounding surfaces, these openings function as anodes and start the corrosion process. Corrosion like this is typical in mechanical parts.

This is a product of microbial activity and may take place in both soils and water. Pipelines, underground infrastructure, and marine constructions are particularly vulnerable to bacterial corrosion.
